“Water Quality Status of Pashan Lake and Manas Lake Linked by Ramnadi River”- An Experimental Analysis

Abstract Water pollution has been one of the major topics in the environmental issue of urban India. Pashan Lake and Manas Lake is an important lake in Pune city which attracts migratory birds. Deforestation on nearby hills has caused heavy siltation resulting in decrease in the depth of the lake. The surface water quality of Pashan Lake is severely degraded due to the pollution from surrounding areas directly entering the water. Eight surface sampling points are selected to evaluate the water quality. The study presents the physicochemical characteristics of the lake water and suggests the means to improve the water quality through eco remediation measures for restoration.

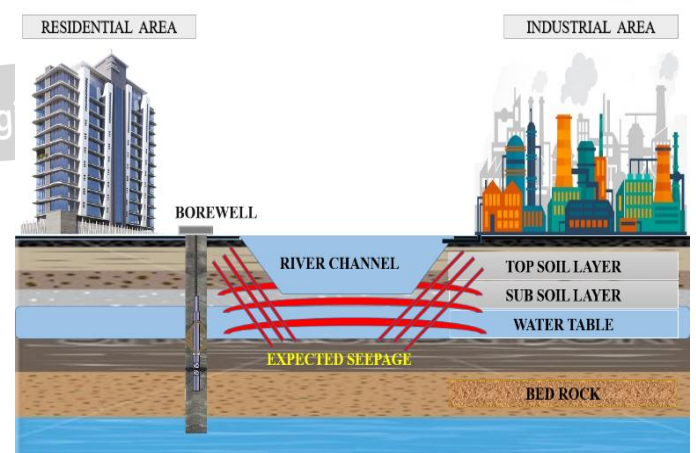
Fig. No. 1: Possible Seepage through river channel

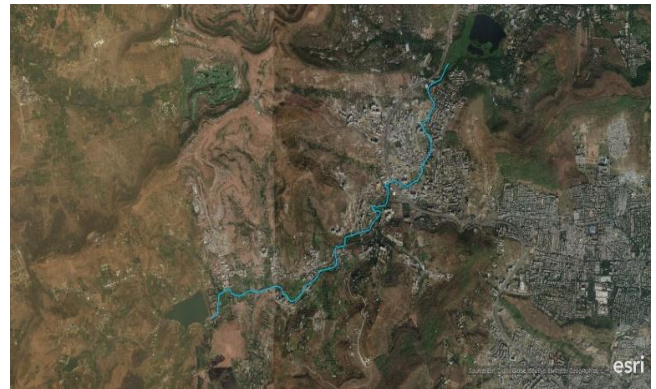
Fig. No.4: Location of Ramnadi from Manas Lake to Pashan Lake [13]

Ramnadi is a river originates from Manas Lake and meets to Pashan Lake and continues towards Mula river. Length of Ramnadi from Manas lake to Pashan Lake is 8.12 km. Ramnadi which further meets Mula River from Pashan Lake is 4.45 km in length. 'Ram river' located at latitude 18°32'7"N and longitude 73°46'58"E. Mumbai – Bangalore highway (NH 4) touches Lake Boundary at North West. Sutarwadi village, is situated, in the North while on the South, a bridge runs connecting Bavdhan road and National Highway No. 4. Ram River enters the lake from East direction.

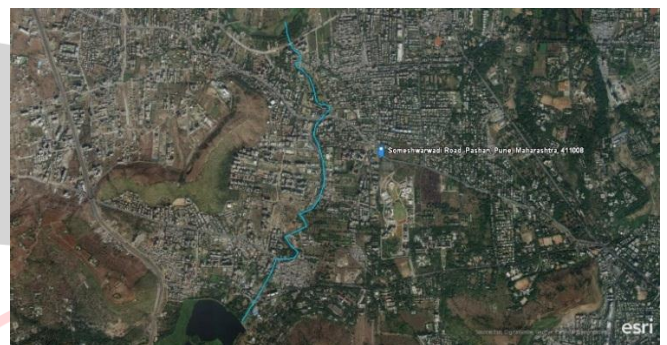
Fig. No.5: Location of Ramnadi from Pashan Lake to Mula River [13]

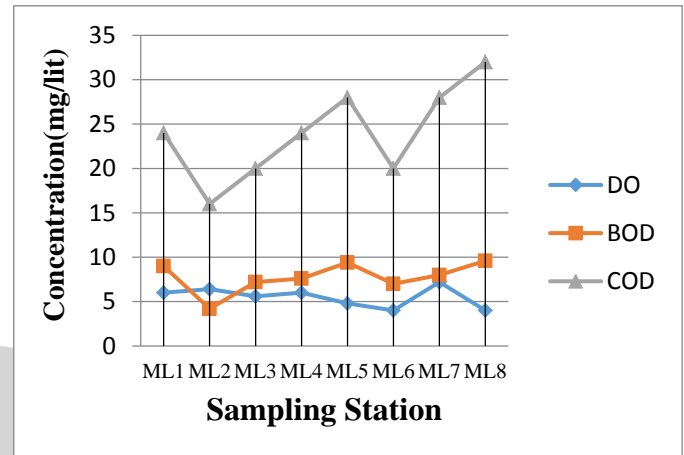
Fig. No. 7: Manas Lake Variation Profile

- DO of Manas Lake varies from 4 to 7.2 mg/lit. DO level in Manas lake is suitable for survival of aquatic life.
- BOD of Manas Lake at ML3 & ML8 is 7.2 & 9.6 mg/lit while COD at ML2 & ML8 is 16 & 32 mg/lit respectively, that means it is within permissible limits.
- Which indicates that the BOD and COD are negligible and water is not much polluted and suitable for use.

- The graph of Manas Lake shows that the results are within the permissible limits and hence the water quality is not much deteriorated and can be used for domestic and Agricultural purposes. Whereas, the Pashan Lake results shows high amount of BOD and COD levels due to dumping of wastes and also due to it has been turned into sewage disposal canal. Also from the biological test it is found that it contains traces of Ecoli bacteria and if such water is consumed it may lead to diseases like typhoid and cholera. Therefore, water of Pashan Lake is unfit to use and needs proper treatment.

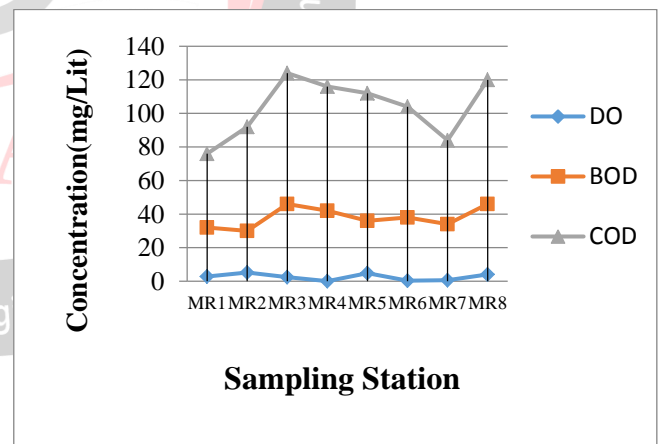
Fig. No. 8: Manas Lake to Pashan Lake (Ramnadi) Variation Profile

- DO level of Ramnadi is found to be very low because the effluent contains high amount of organic wastes depleting the oxygen level and at some places it is found below the detectable level causing threat to water quality.
- BOD level varies between 32 to 46mg/lit due discharge of domestic wastes from the adjoining slum areas.
- COD at MR1 is 76mg/lit which is further increased to 120mg/lit at MR8 due to sudden discharge of organic waste at MR8.

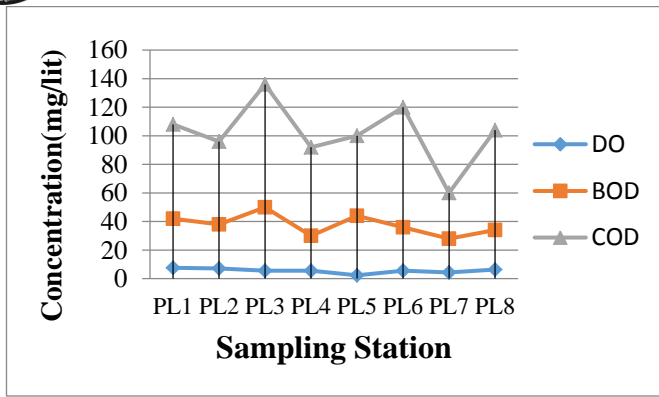
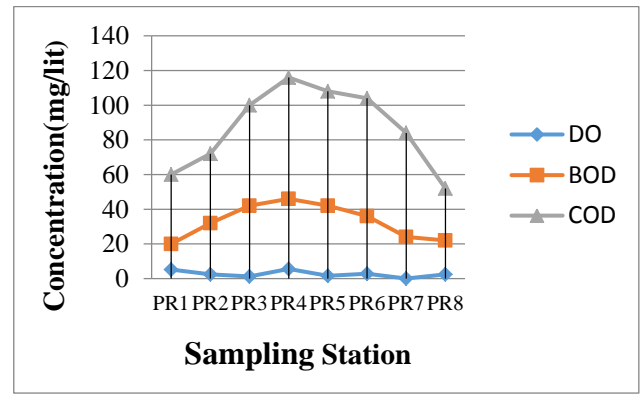
Fig. No. 9: Pashan Lake Variation Profile

- DO level is found to be critical at PL5 because there is rapid increase in the growth of water hyacinth which leads to the depletion of dissolved oxygen.

- Water hyacinth contributes to the organic waste in water, which is further decomposed by bacteria. This results to high BOD level at PL3 and PL5.
- The high COD (136mg/lit) and BOD (50mg/lit) level at PL3 is found due to presence of domestic waste and toxic industrial wastes.

- When BOD and COD levels are high, DO levels decrease because the oxygen that is available in the water is being consumed by the bacteria. Since less dissolved oxygen is available in the water, fish and other aquatic organisms may not survive.

- DO content at PR4 is 5.6mg/lit, but it is observed that it is decreasing after PR4 due to organic waste disposal from local areas.
- There is an increase concentration of BOD and COD results at PL4, PL5 and PL6 of river due to discharge of soluble organic compounds contained in wastewater.

- The river also contains toxic and inorganic waste, therefore leading to an increased concentration level of COD.
- The increase in the BOD and COD levels together has contributed to the diminution of dissolved oxygen (DO) content in river water.
