# Analysis and Risk Assessment of Structures on Hilly Areas: Case Study of Pune City.

**Aim:** To study structures in terms of construction and identify Risk prone buildings on hilly areas with a case study of Katraj Hills.

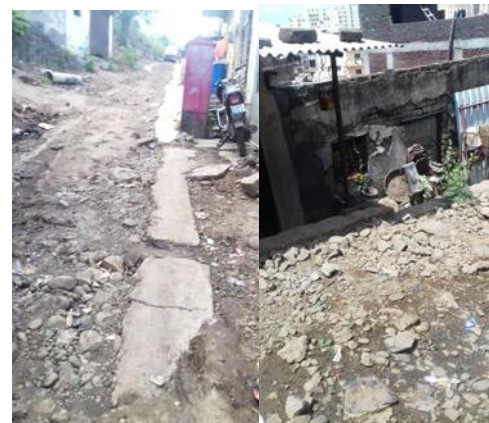
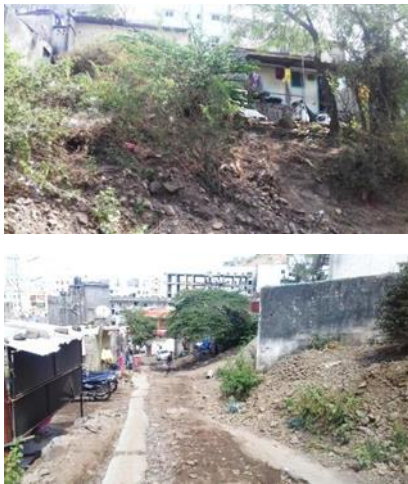
Figure 6: Site Photographs taken by Author

The foundation of the structure is an important part to consider while mitigating risks. RCC foundations are proven stronger to resist and e stable for many years if proper concrete mix design and site development is done. By the observations done, it is found that there was landslide which did not cause major destruction but some damage. Some structure have developed cracks, some structures appear weaker, the roads and drainage system is poorly maintained, some structures have gone partially under the ground as layer of soil has displaced. Despite there were concrete roads in this area, they failed to perform during heavy rains as all the soil and rocks fell all over the road. The roads made by massive cutting on one side should be treated accordingly so that minimum rock falling and landslide happens. (Figure 5) Proper runoff water storage or flow should be designed along with the drainage system. This reduces the collapse of roads and building exterior damage. Landslide Preparedness Guidelines for Safety of Buildings on Slopes is given by NIBM they should be followed. [6] The observations are road damage, soil erosion into houses and no provision of retaining walls and lack of site development. (Figure 6)

retaining walls to hold the earth on slopes, Compacting weak soil at not only individual plots but the whole area helps reducing landslides.
